PROPERTY CONDITION ASSESSMENT

Westminster Presbyterian Church
17 William Street
Auburn, New York

February 21, 2022

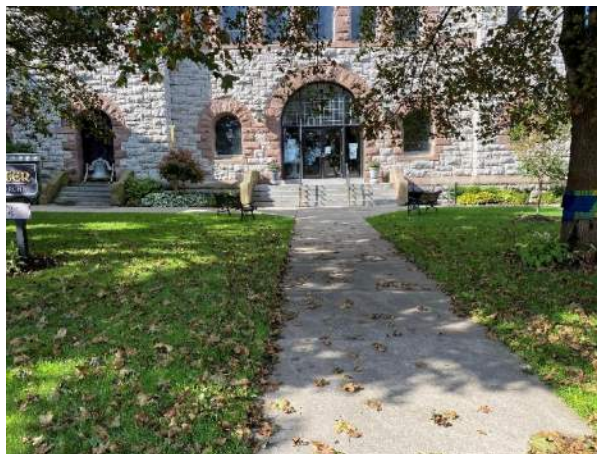
Main Entrance -Sanctuary Building

A set of stairs connects the sidewalk on the east side of the building to the main entrance. The main entrance stairs appear to be in good condition, but the handrails don't meet current code requirements (See Appendix B).

- Replace non-code compliant handrails at the east facing main entrance and south facing accessible entrance to the Sanctuary Building
- Replace existing handicapped accessible parking signs with current code compliant signs including one van accessible sign.

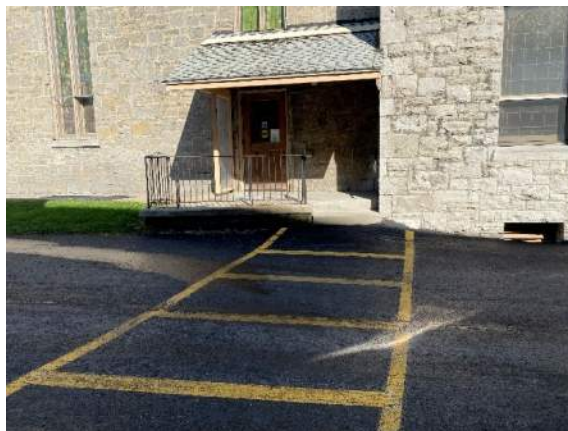
Accessible Entrance to Sanctuary Building

A small set of stairs leads from the access driveway on the south side of the Sanctuary Building to the accessible entrance. The stairs are in good condition, but the handrail does not meet current code requirements (See Appendix B).

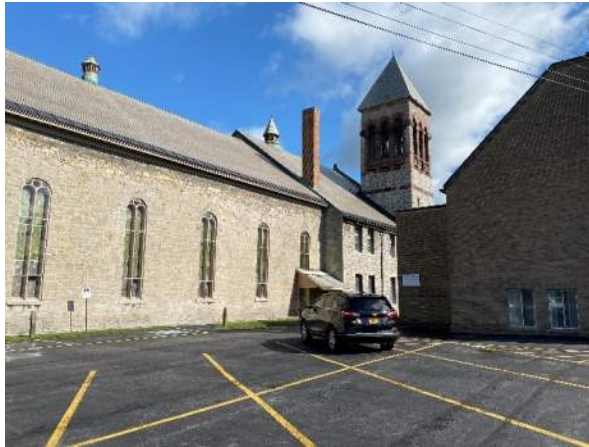
Asphalt Parking Lot South at Sanctuary Building

Vehicular pavements at the subject property include a single lane asphalt paved egress driveway off William Street, an entrance and egress driveway off Court Street and a parking lot located south-west of the Sanctuary Building. The parking lot contains 29 parking spaces including 3 accessible spaces. The parking lot and access drives are in relatively good condition and currently only require routine periodic maintenance.

- Provide crack and pavement sealing and restriping of parking lot and access driveways within 5-years.
- Provide a gutter and downspout system for the Sanctuary Building and connect downspouts underground to a perimeter storm drainage system. Convey stormwater from roof to the existing William Street storm drainage system. The Education Building has gutters and downspouts. Tie existing downspouts into an underground perimeter storm drainage system. Convey stormwater to the existing William Street storm drainage system.

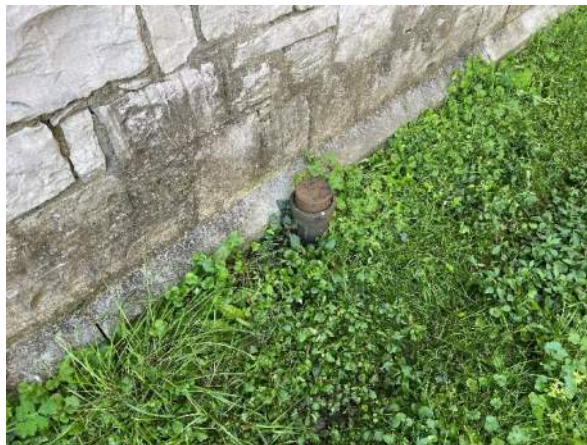
It appears that the majority of a gutter/downspout system for the Sanctuary Building was removed at some point. A small portion remains on the south side of the building. This condition has allowed sheet drainage from the roof to infiltrate into the building's basement.

Typical Capped Roof Drain at Sanctuary Building

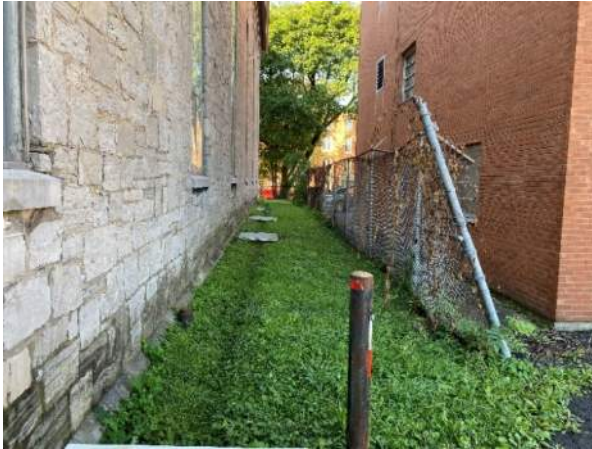
Sanctuary Building: The 6-foot chain link fencing on north side of the Sanctuary Building is in poor condition; several posts are bent, broken, or leaning over and fence sections are rusted. The 4-foot-high chain link fencing around the playground is in fair condition; some sections are showing signs of deterioration. The south section(s) of fencing are removed in the winter for snow removal and replaced in the spring.

Damaged Chainlink Fence, Northwest Side of the Sanctuary Building

- If property boundary and topographic survey confirms chain link fencing located along north and south property lines are owned by Westminster Presbyterian Church, replace existing fencing in kind.

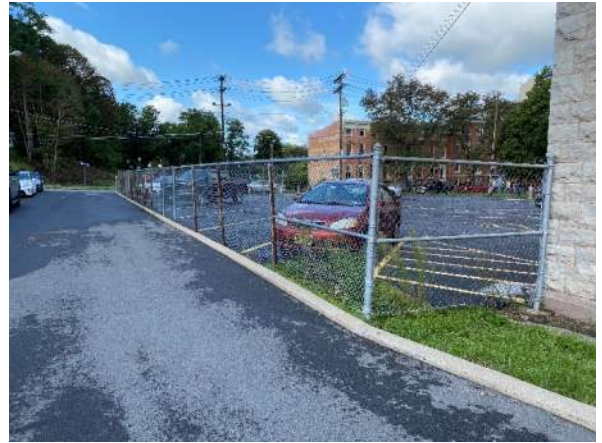
Education Building: The 6-foot-high chain link fence on the south side of the Education Building is in poor condition; several posts are bent and leaning over, and several posts and fence sections are rusted.

Damaged Chain-link Fence South Property Line

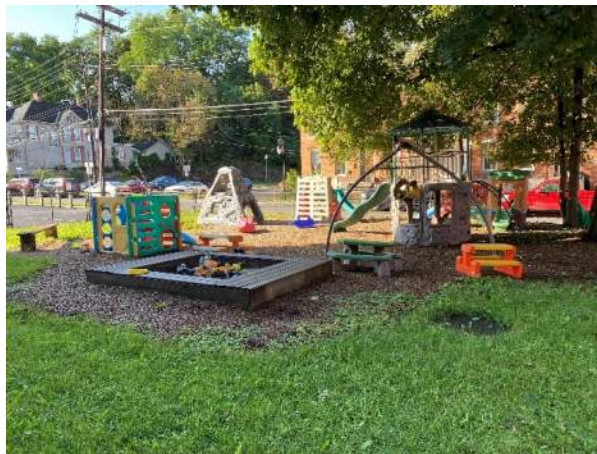
Existing Playground

There are a number of codes and guidelines that relate to playgrounds including the ADA, ASTM technical standards and the US Consumer Products Safety Commission Guidelines. A third-party Certified Playground Safety Inspector (CPSI) will be able to conduct a safety inspection of the existing playground including hazard identification, equipment specifications, surfacing requirements and risk management methods.

- Engage a third-party Certified Playground Safety Inspector (CPSI) to conduct a safety inspection of the existing playground including hazard identification, equipment specifications, surfacing requirements and risk management methods.

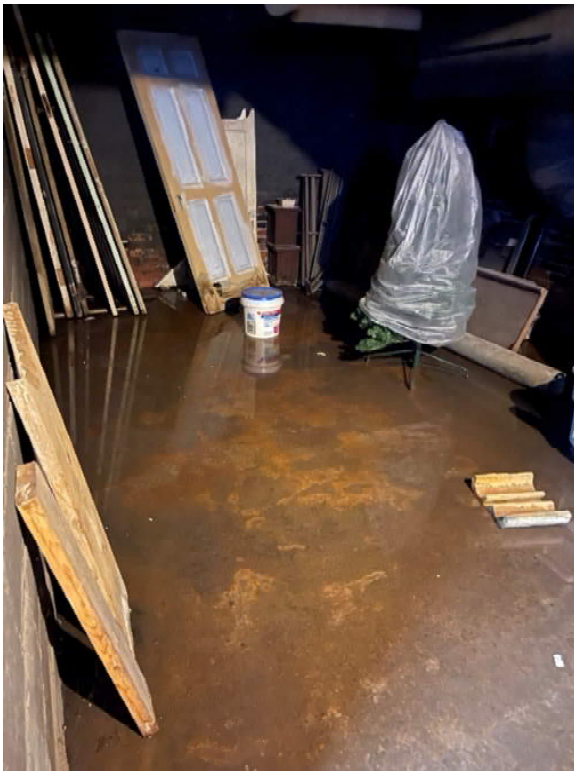
During the site reconnaissance, significant standing water was observed throughout the basement areas. Additionally visible seeping water was observed coming through the foundation walls.

Standing Water in Room Adjacent to Boiler

It is currently believed that the water infiltration is a result of several contributing factors: deteriorating/missing mortar from foundation wall, removed gutter/downspout system allowing sheet drainage off the high sanctuary roof, damaged or missing perimeter drainage system, areaways with open vents, and basement wood windows with visible rotting frames. Refer to other sections of the report for a more detailed breakdown of the contributing factors and recommend corrective actions.

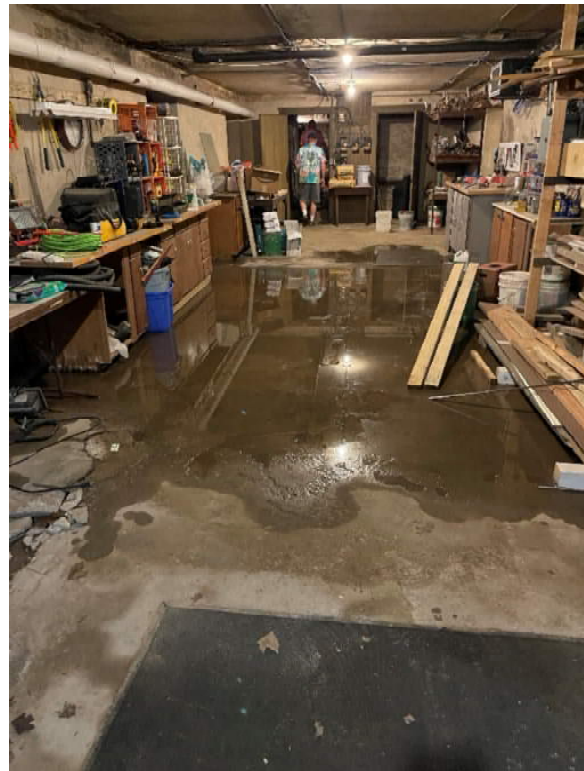
Standing Water in Maintenance Area

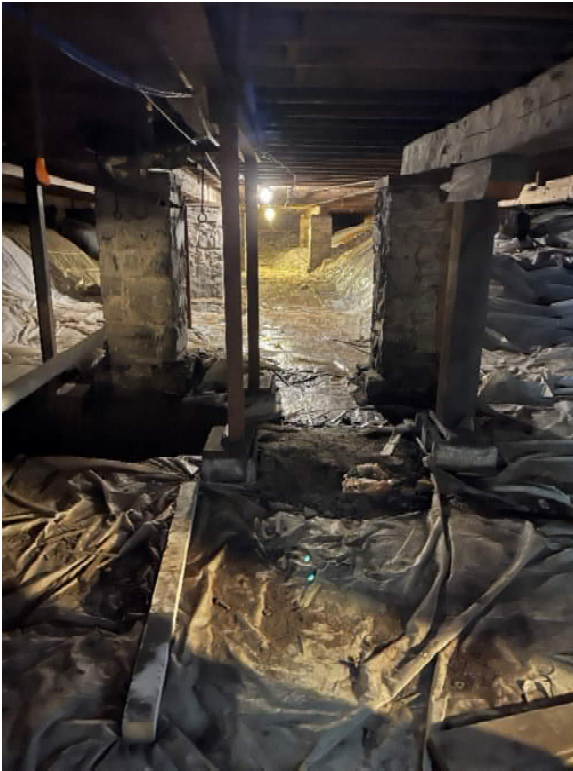
The stored materials in contact with the floor and standing water are absorbing the moisture, thus deteriorating the store materials (i.e., wood lumber, extra doors, scrap wood, workbenches, etc.) Continued exposure to moisture will result in rot and promote and accelerate mold growth.

Plastic Over Mounded Earth

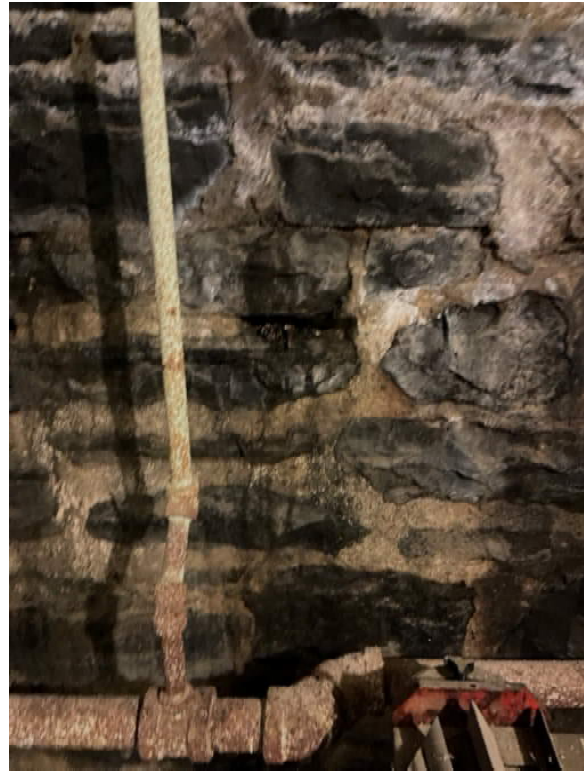
Visible Water Seeping Through Foundation Wall

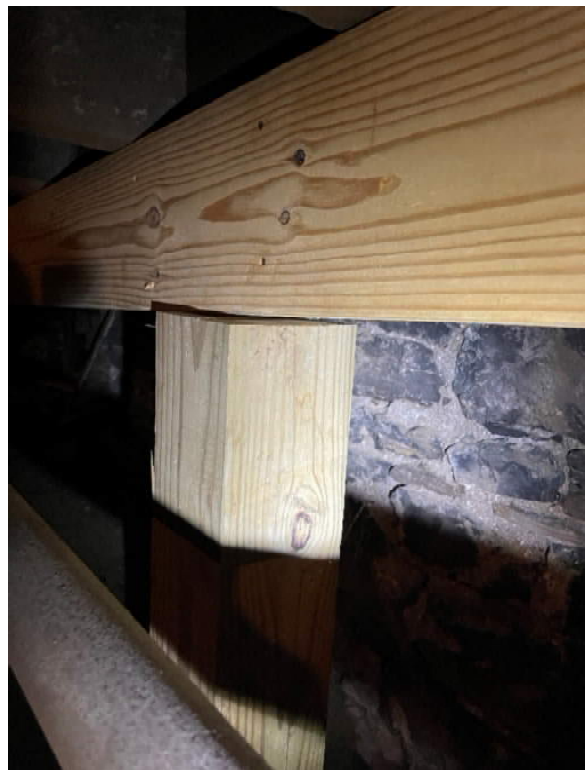
Wood Column not Secured to Beam and is not Square to the Underside

The above photos do not represent all the conditions observed but are intended to illustrate the severity of the condition. Un-anchored and non-engineered shoring has the potential to slip out of position, which can result in structural failure.

- Maintain the temporary shoring in-place and engage a structural engineer to design a more permanent solution
- Until an engineered solution is provided, secure tops and bottoms of posts and replace or reposition diagonal bracing and secure to support beam

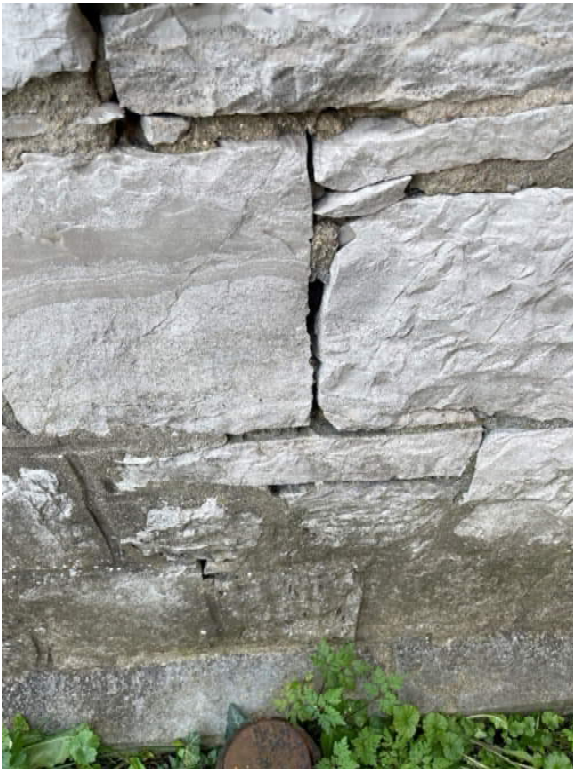
Generally, the stone masonry was observed to be in good condition; however, the mortar joints between the stone masonry are showing evidence of significant failure around the building's exterior and interior basement walls. The failing mortar joints, especially the ones lowest to the ground, are contributing to water infiltration into the basement and wall system. During the winter months, any moisture in these joints will expand as it freezes and further damage the joint integrity.

Missing and Deteriorating Exterior Mortar

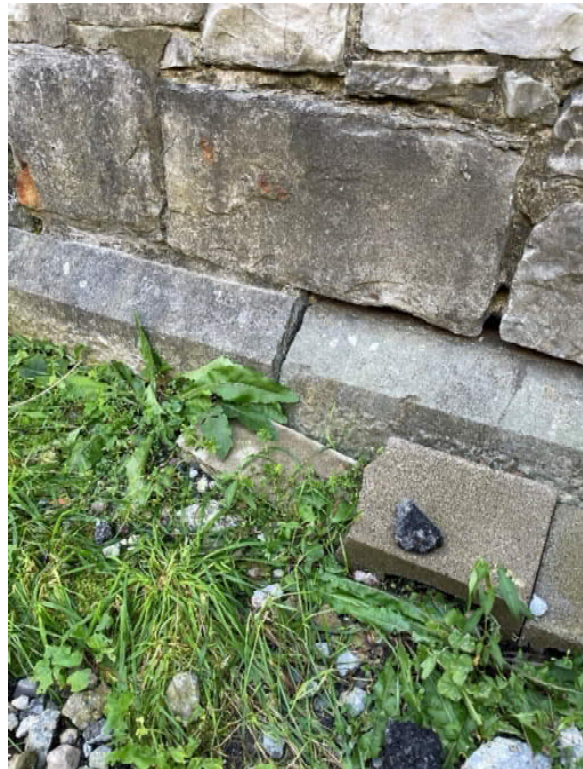
Mortar is Completely Missing Above the Sill Stone and The Sill Stone is Dislodged/Sinking (See Image Below as Well)

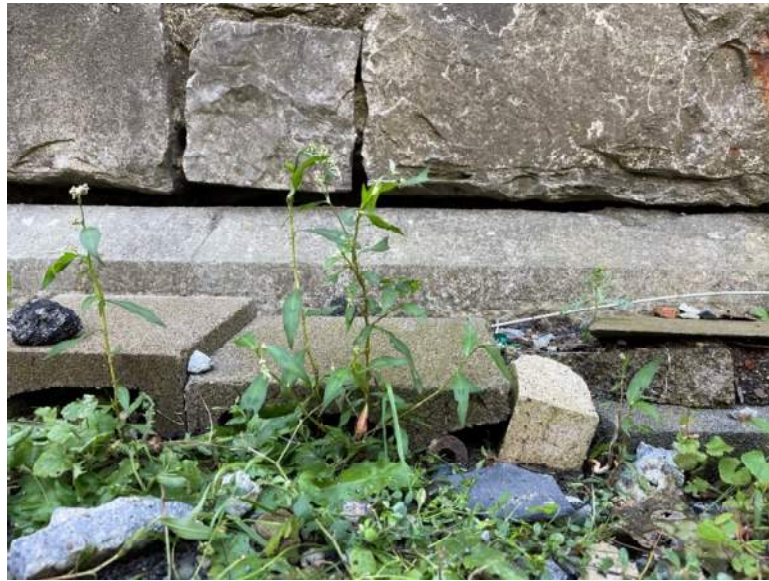
The Above Photos are Taken Along the North Wall Where Beardsley Observed the Temporary Shoring.

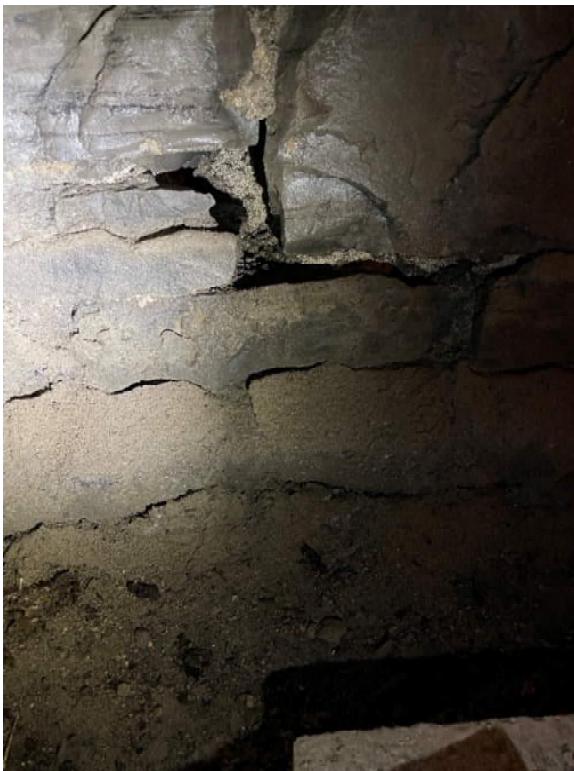
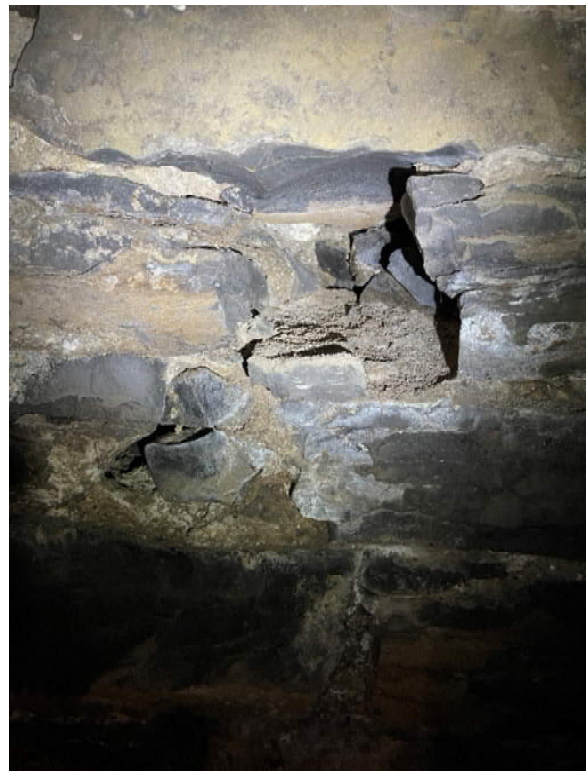
Deteriorated Mortar Inside the Foundation Wall. The mortar is Loose and Powdery and Falling Out of The Joints Creating a Pile at the Base of the Wall.

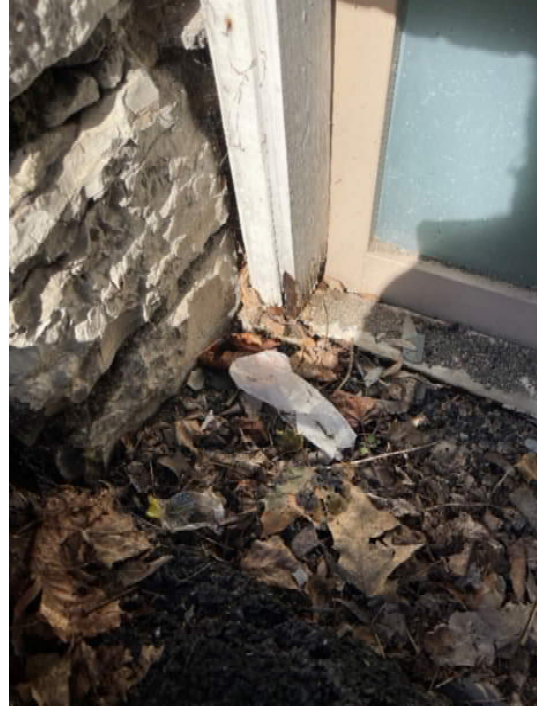
The wood windows in the areaways below grade are showing evidence of rot at the frames and are not properly sealed. The bottom of the window sashes is within one inch of the bottom of the areaway. The failing wood windows along with their proximity to grade is contributing to water infiltration in the basement.

Typical Areaway Condition

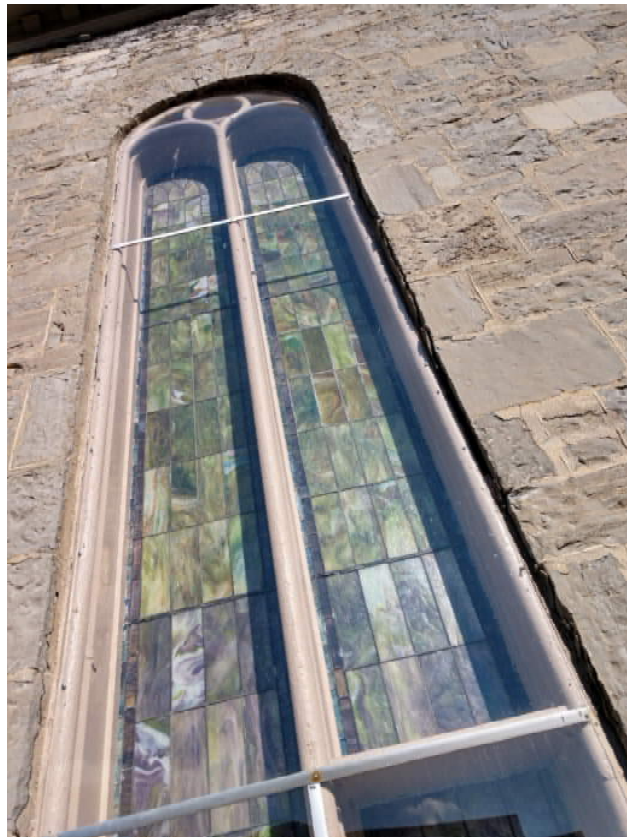
Typical Sanctuary Wood-Stained Glass Window With vented plexiglass panel and Cracking Along Both Sides of The Window.

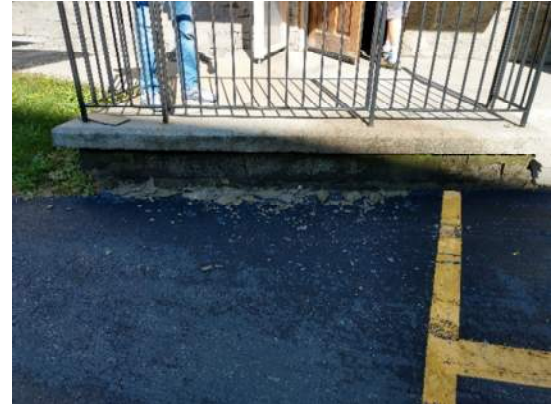
Concrete Parging Falling Off

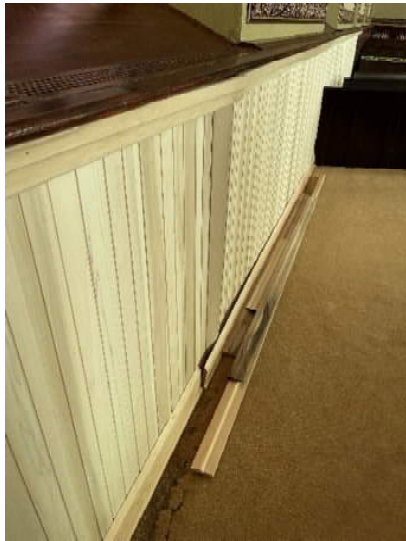
Damaged wainscot (in process of being replaced)

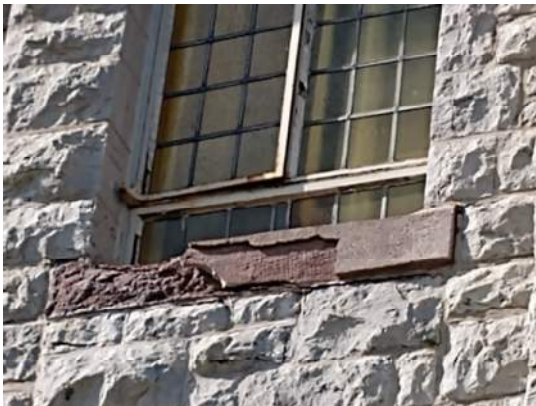
Windowsill

There are a few stone windowsills, stone window heads and molding that are deteriorating and need to be replaced.

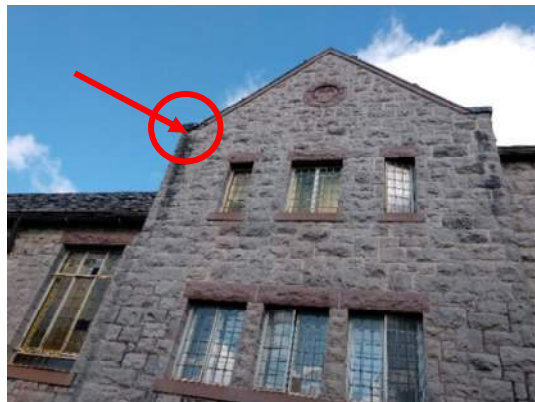
Stone molding deterioration at top left corner. This may also be contributing to the dark staining on the stone masonry

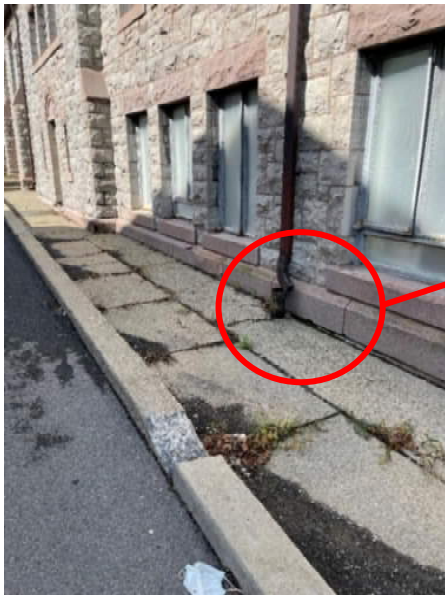
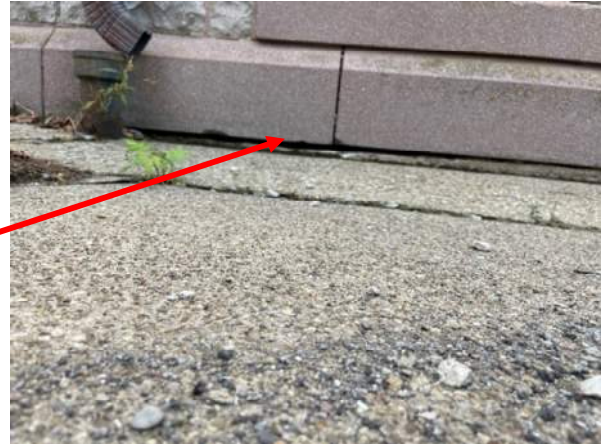
The downspout above drains directly along the face of the building and the force of the water is deteriorating the mortar joints. Similar conditions can be seen all along the south face.

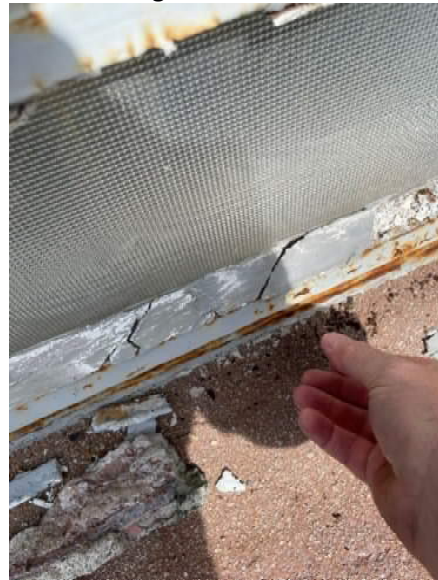
Close-up of deteriorating glazing compound

- Provide hazardous materials testing on the glazing compound and surrounding sealants
- Fully replace all window units in the Education Building with energy efficient, double-pane, window units. The new window units will need to mimic the existing window aesthetics, operation, and frame profiles as much as possible to honor the building's historical character. Any window replacement will need to be reviewed by the City of Auburn's Historic Resources Review Board as mentioned in 2.1.10.
- Evaluate aluminum and commercial non-metal high-strength materials such as fiberglass.

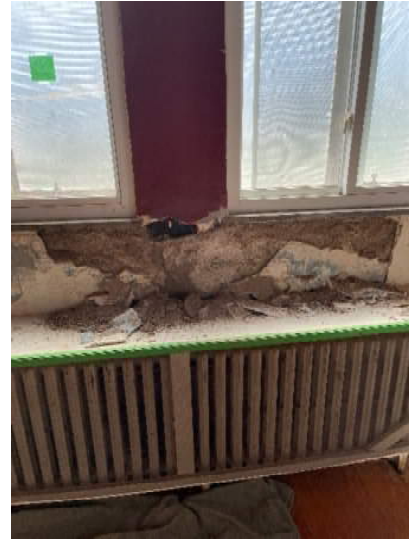
Damaged plaster at windows

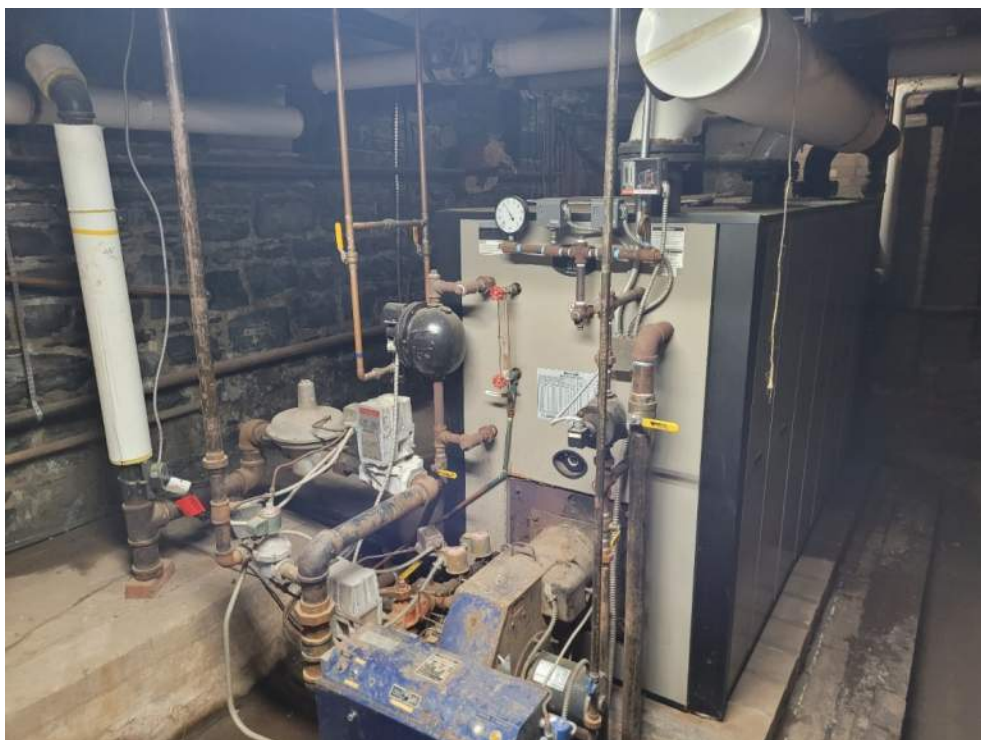
Existing Cast Iron Sectional Steam Boiler

The heating for the building is steam, provided by a single cast iron sectional boiler located in the basement of the sanctuary building. According to Mark Patterson, who services the steam system, this boiler is approximately 8 years old. This boiler appears to be in good condition, however a recent steam leak caused cold makeup water to be added to the boiler which damage the last four cast iron sections at the back of the boiler. Work is already scheduled to replace these sections. Because there is only one boiler, there is no capability for backup heat in case the boiler fails.

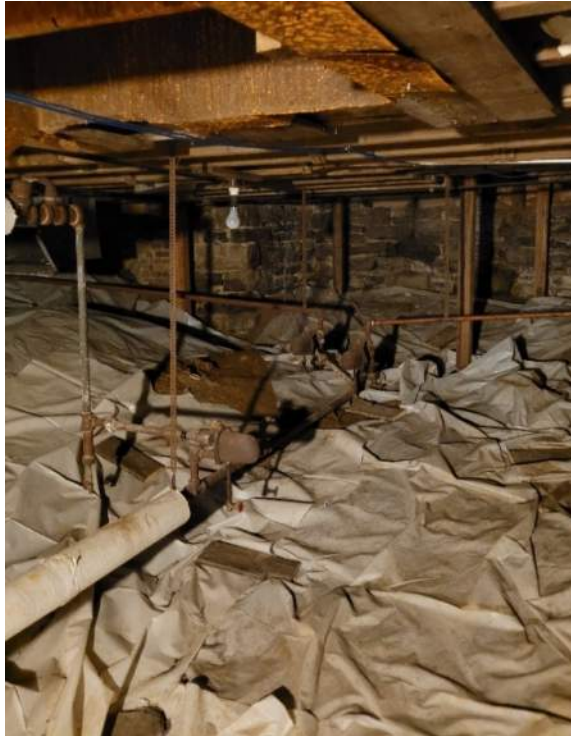
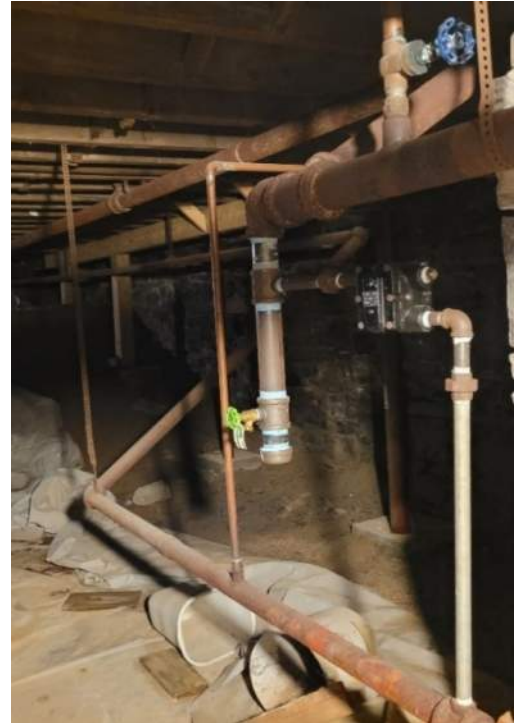
A good portion of the steam and condensate piping in the basement is uninsulated. Piping needs to be insulated in accordance with the Energy Code of New York State

Uninsulated Steam & Condensate in Basement

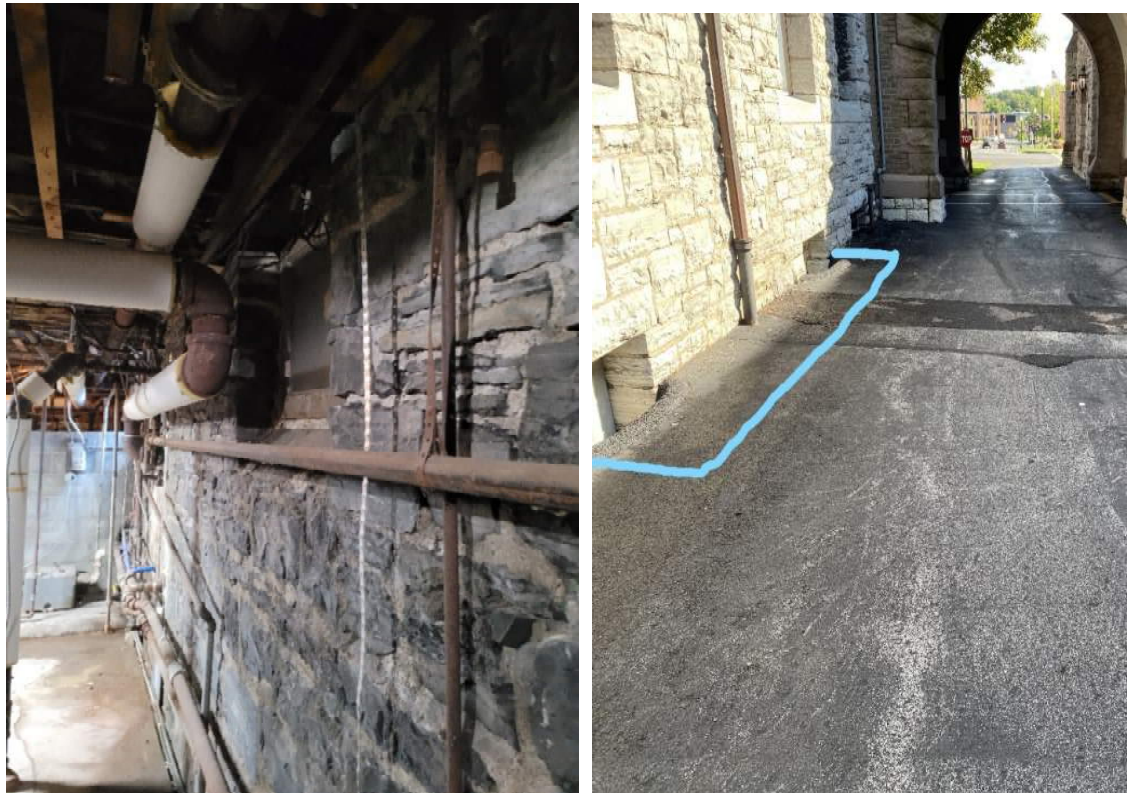
Interior and Exterior of South Wall of Boiler Room. Line indicates approximate size of Areaway.

- Provide combustion air intake in accordance with Code. This will require that two 16 square foot louvers be provided in the exterior wall. One within 12" of the ceiling and one within 12" of the floor. To facilitate this, piping along the south wall of the boiler room will need to be reworked and an areaway will need to be provided along the exterior wall.
