PROPERTY CONDITION ASSESSMENT

Westminster Presbyterian Church
17 William Street
Auburn, New York

February 21, 2022

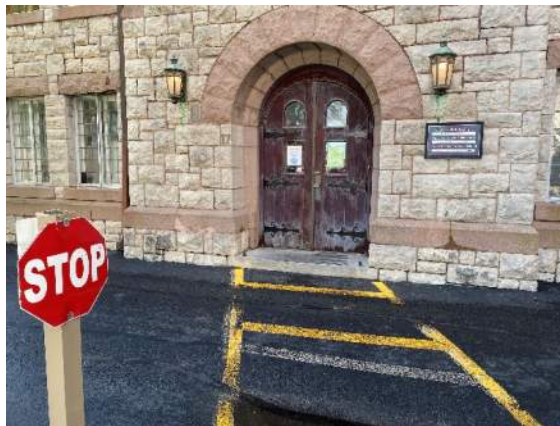
Main Entrance to Education Building

A set of stairs connects the sidewalk on the east side of the building to the main entrance. The main entrance stairs appear to be in good condition, but the handrails don't meet current code requirements (See Appendix B).

- Replace non-code compliant handrails at the east facing main entrance and south facing accessible entrance to the Sanctuary Building
- Replace existing handicapped accessible parking signs with current code compliant signs including one van accessible sign.

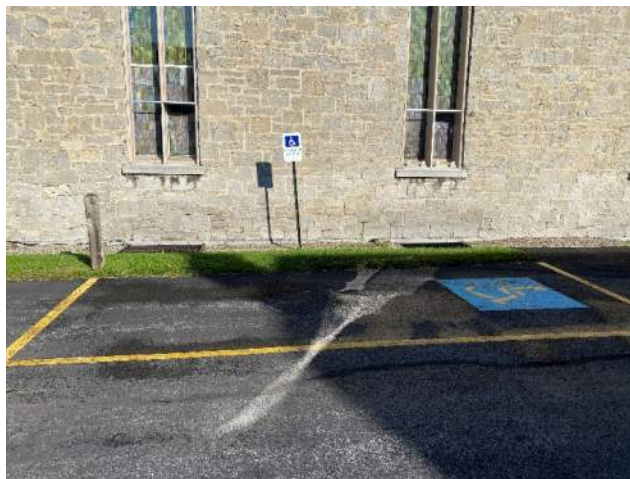
According to ADA standards, the minimum number of accessible parking spaces for a parking lot with 29 spaces is 2: one standard ADA space and one van-accessible ADA space. The current 3 ADA spaces meets the minimum required number; however, one space is not designated as a van-accessible space and requires proper signage.

Typical Accessible Parking Space

The location of the ADA parking spaces being closest to an accessible entrance and the dimensional size of the parking spaces meets ADA requirements. Although there are upright signs designating each accessible space, the signage is outdated. New York State in recent years has updated the ADA symbol to be used for signage and paint striping.

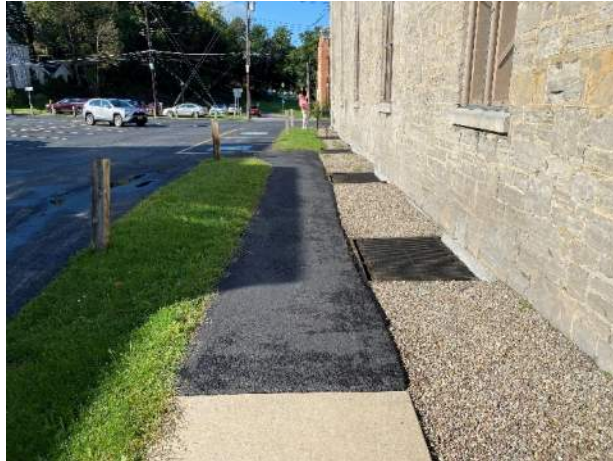
Accessible Route to Sanctuary Building

The accessible route meets the minimum dimensional requirements of the ADA guidelines as well as slope and level change requirements.

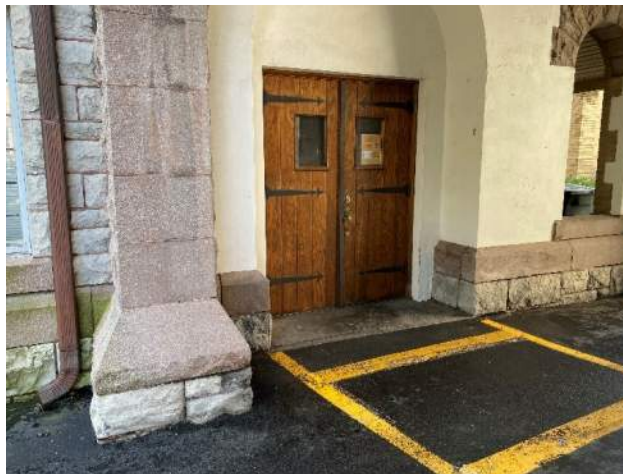
Accessible Entrance to Education Building

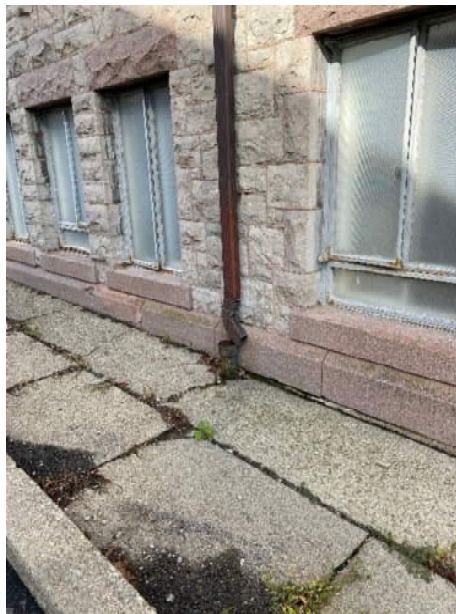
The Education Building does have a gutter and downspout system in place however some of the downspouts extend below grade while other downspouts discharge to grade adjacent to the building. It is unknown if the downspouts that extend below grade connect to a functioning perimeter drainage system.

Typical Disconnected Roof Drain – Education Building

- Provide crack and pavement sealing and restriping of parking lot and access driveways within 5-years.
- Provide a gutter and downspout system for the Sanctuary Building and connect downspouts underground to a perimeter storm drainage system. Convey stormwater from roof to the existing William Street storm drainage system. The Education Building has gutters and downspouts. Tie existing downspouts into an underground perimeter storm drainage system. Convey stormwater to the existing William Street storm drainage system.

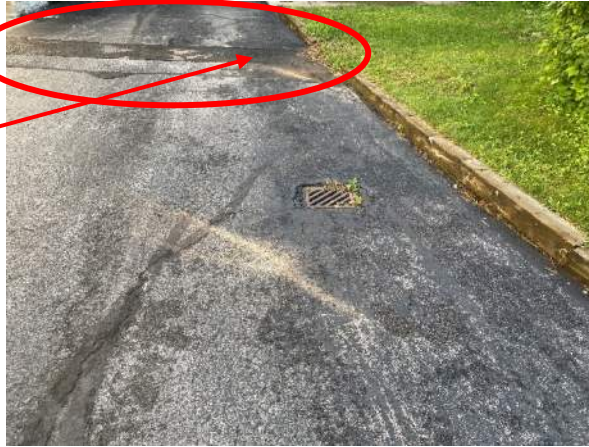
Storm Drain at Driveway Between Buildings

Additionally, during winter months, the snowplow is unable to scrape snow/ice to the level of pavement. The steam line tunnel (identified above) rejects heat to the asphalt and continually melts the snow, which then re-freezes over and again, creating a large ice dam. This build-up of ice poses a safety hazard for vehicle and pedestrian traffic.

Further assessment of the site drainage will need to be conducted in conjunction with the site survey by way of video examination of underground piping and/or ground penetrating radar to identify underground piping layout. The stormwater management will need to be worked out closely with the City of Auburn DPW.

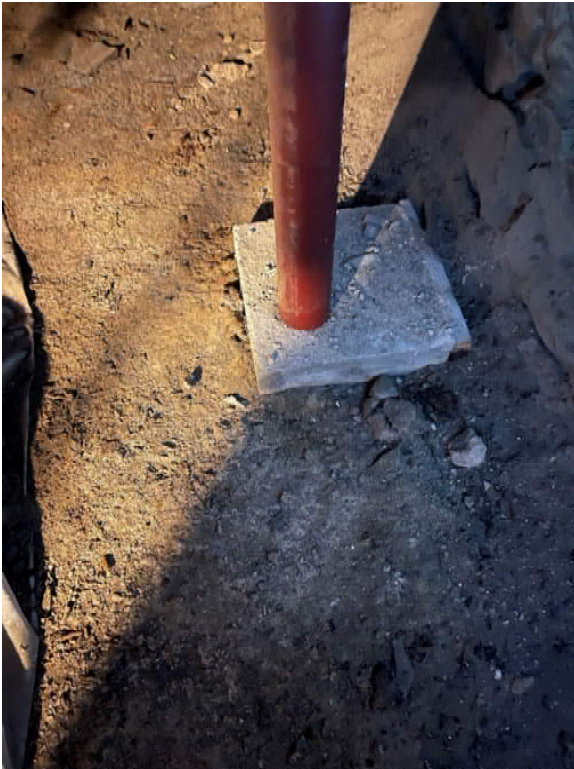
Off-Center Lally Column Shoring

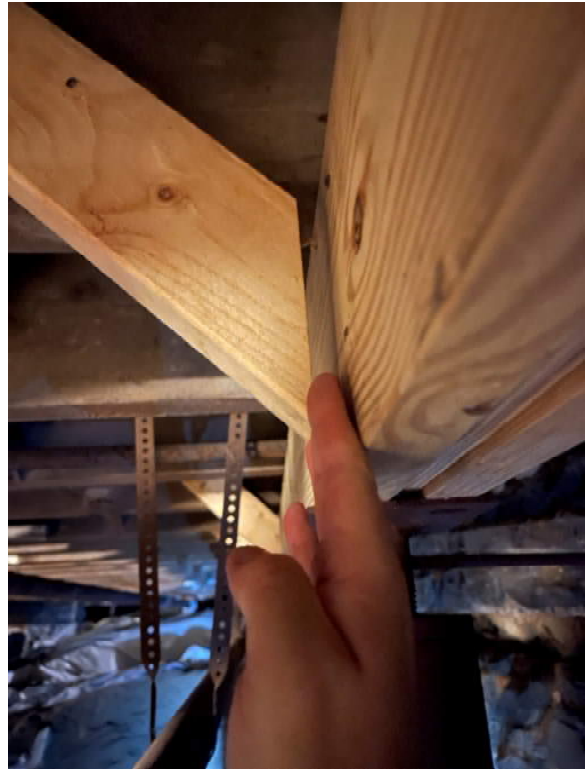
Diagonal Bracing not Secured to Beam

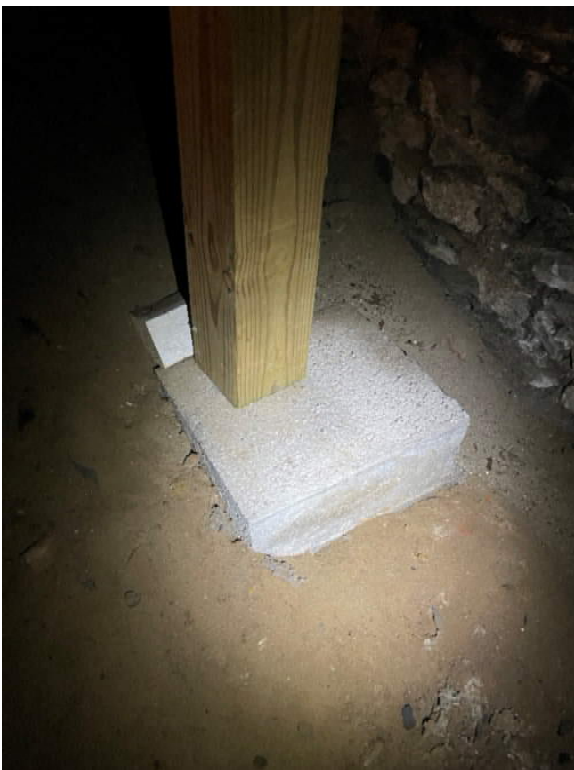
Wood Shoring Column Not Centered/Secured to pad

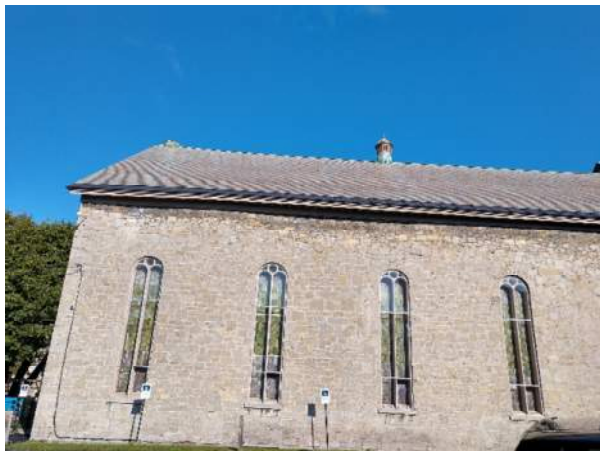
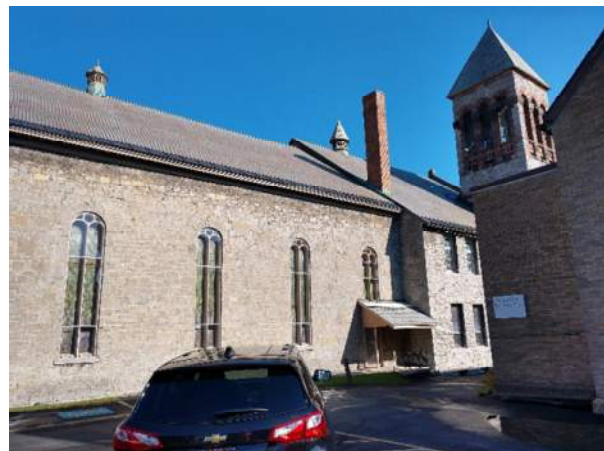
South Side of the Sanctuary Roof and Elevation

The existing slate roof is in fair condition; however, some slate tiles were observed on the ground on the north side of the building. The failed slate tiles will need to be replaced.

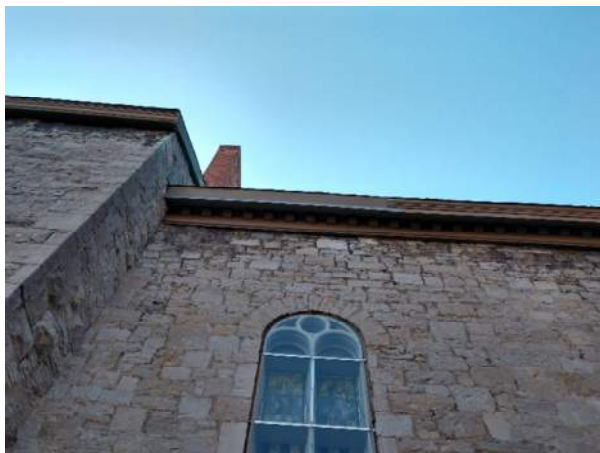
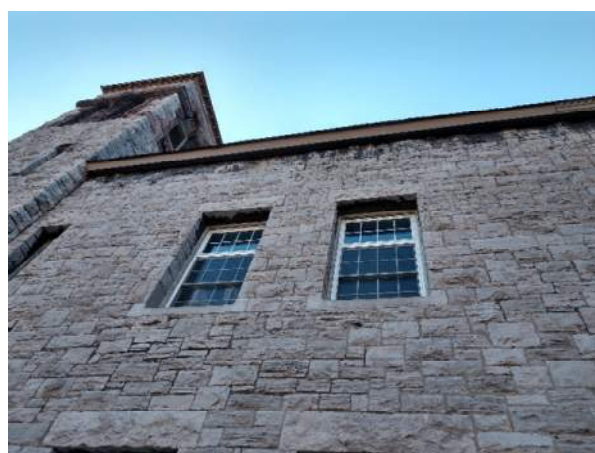
North Face of Soffit/Fascia of Sanctuary

The Soffit and Wood Fascia appear to be in fair condition.

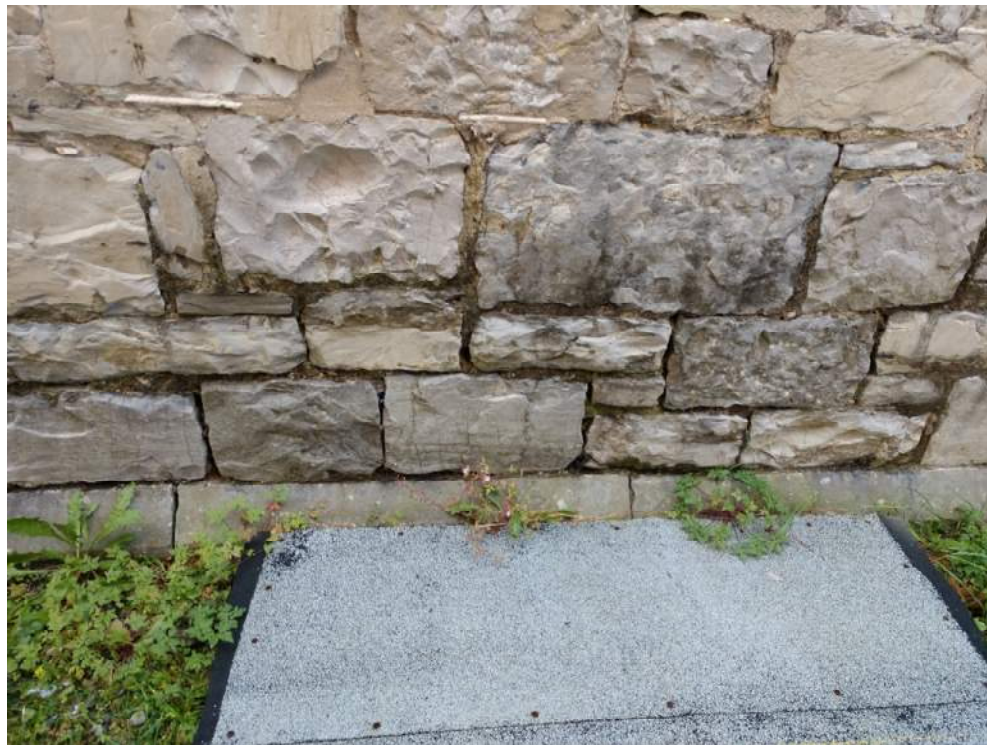
As described in 3.2.1.4 there is mortar joint deterioration around the Sanctuary base of wall. The reason for this deterioration is the amount of water coming off the roof and splashing on the building. The deteriorating mortar is contributing to the basement water infiltration. The photo below shows that the covered areaways are creating additional water splashing and deterioration on the building. Our recommendation is to provide gutters around the sanctuary to protect the mortar joints.

Additional investigation will need to be performed to determine if the storm lines below ground are still active and can be reused, which starts with a new property survey and research into how the abandoned system tied into the municipal system. Additional investigation options to consider are Ground Penetrating Radar (GPR) and/or video scoping to document the underground condition and location of the existing abandoned drainage lines more accurately.

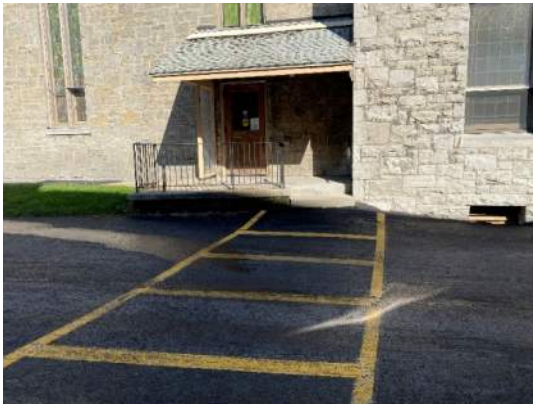
The accessible entrance is covered with a shed roof, constructed of wood rafters and ledgers secured to the face of stone masonry. There is a plexiglass wind screen that is framed into the wood that also doubles as a support wall. The roof is covered in asphalt shingles there are deteriorating and curling at the corners. The entry door itself is a heavy wood door that is sun-bleached and dated. The door is equipped with an electronic push button device to accommodate accessible entry.

Accessible Entry and Shed Roof

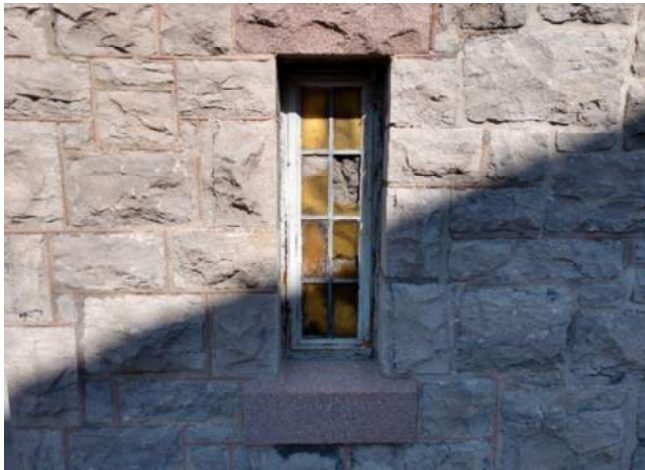
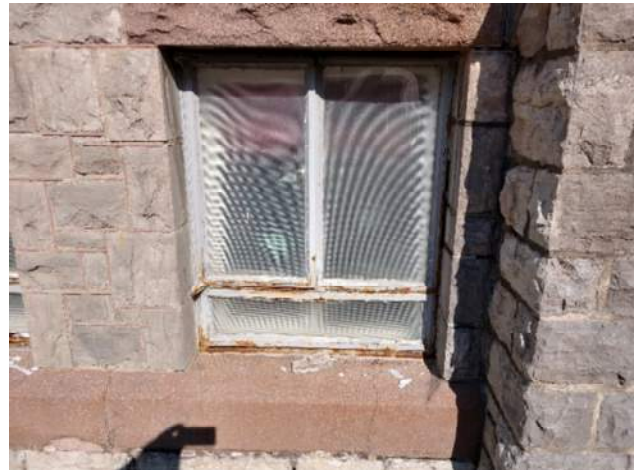
Close-up of steel windows at Education Building

- Provide hazardous materials testing on the glazing compound and surrounding sealants
- Fully replace all window units in the Education Building with energy efficient, double-pane, window units. The new window units will need to mimic the existing window aesthetics, operation, and frame profiles as much as possible to honor the building's historical character. Any window replacement will need to be reviewed by the City of Auburn's Historic Resources Review Board as mentioned in 2.1.10.
- Evaluate aluminum and commercial non-metal high-strength materials such as fiberglass.

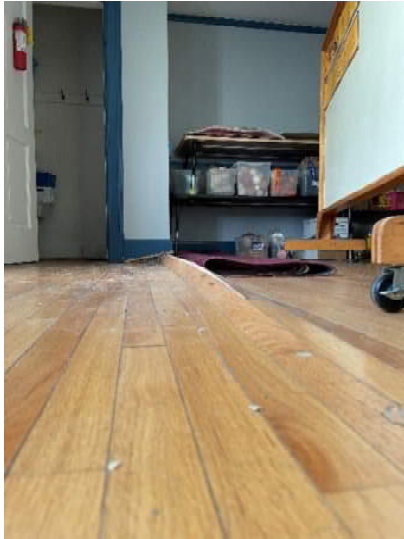
Heaved wood floor from burst steam line

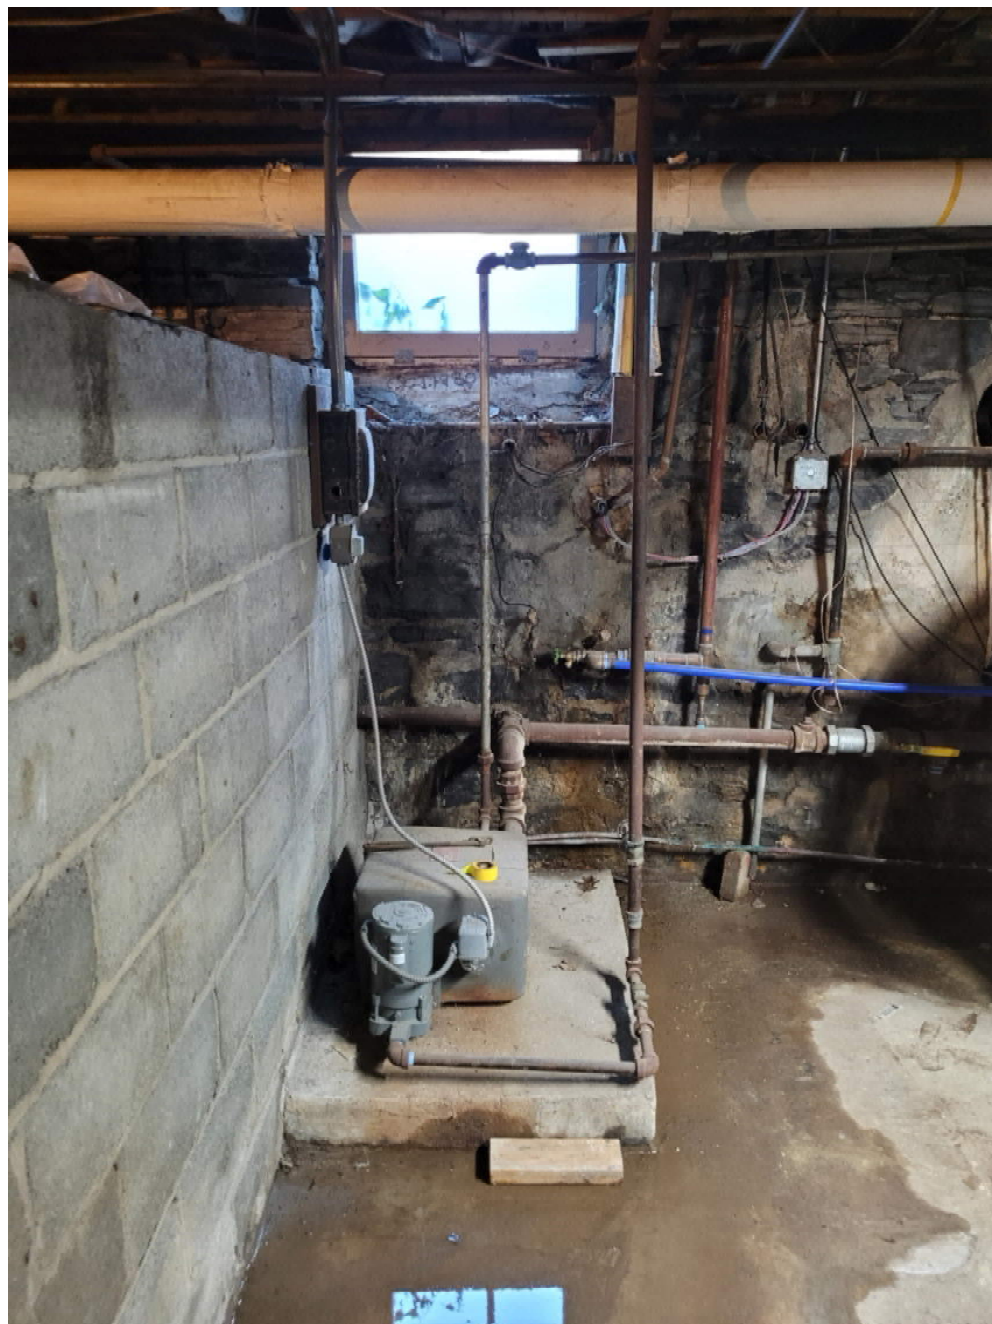
Steam and condensate are piped throughout the building to a combination of convectors and cast-iron radiators. For the most part all piping and associated terminal units appear to be original equipment and are way beyond their expected service life. Mark Patterson reported that piping has needed to be repaired/replaced on a consistent basis.

A good portion of the steam and condensate piping in the basement is uninsulated. Piping needs to be insulated in accordance with the Energy Code of New York State

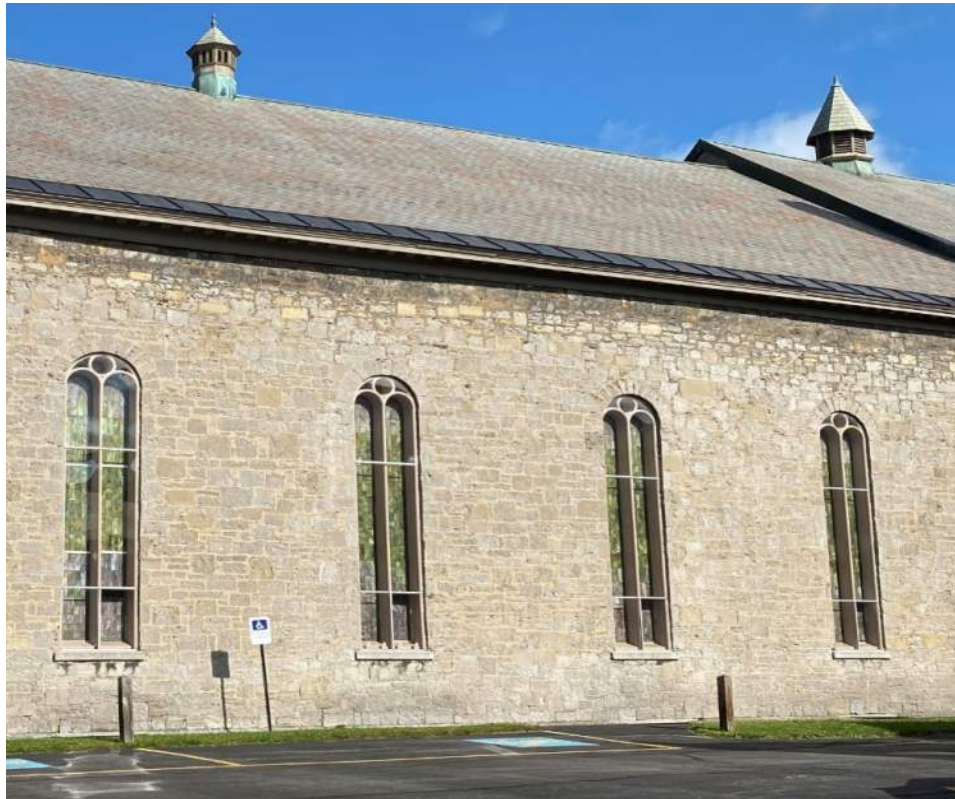
Ventilation for the building is provided by operable windows. While operable windows are acceptable by code, the windows are likely closed during the winter months which does not allow for adequate ventilation. The original exhaust system was a gravity relief system with relief grilles located in various spaces, mainly toilet rooms, and the sanctuary. Toilet exhaust fans have been installed in the toilet rooms and tied into the relief air ductwork. These grilles/fans are ducted up to and discharge into the attic space. Discharging toilet exhaust to an attic space is against the Mechanical Code of New York State. Roof mounted gravity relief vents are provided for ventilation of the attic space. Ventilation for the basement is through operable windows only with no means for exhaust.

Two Gravity Relief Vents on Sanctuary Building Roof

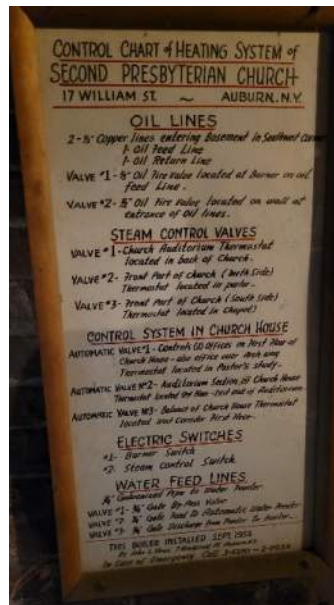
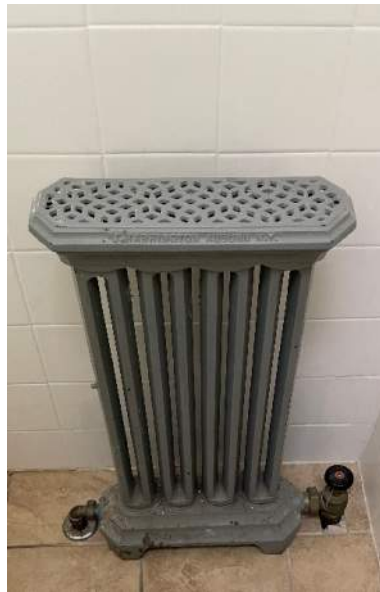
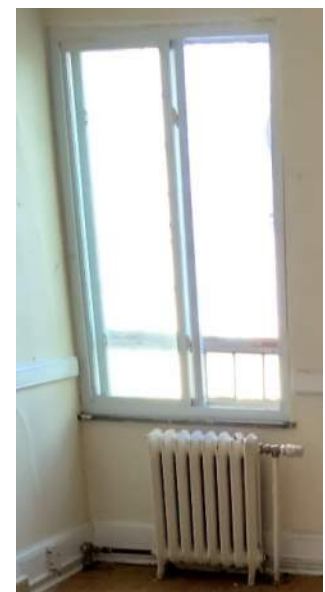
Controls for the heating system are electric, with the building divided into three zones, the north side of the front portion of the sanctuary building, the south side of the front portion of the sanctuary building and the sanctuary. Each zone consists of a wall mounted thermostat controlling a steam control valve the serves the zone. Terminal units are provided with a combination of manual control valves and self-contained thermostatic control valves for individual space temperature control.

List of Steam System Zone Valves & Photos of Manual and Self-Contained Control Valves

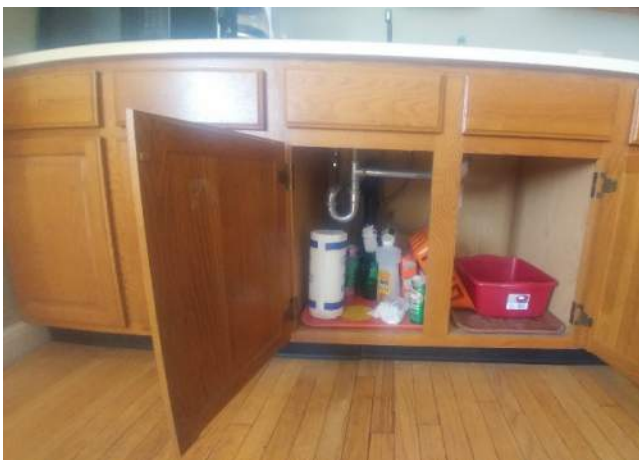
- Observed mainly exposed Sch.40 PVC sanitary waste and vent piping in various areas. Sch. 40 PVC appears to have been utilized for the more recent toilet room and kitchen renovations.
- Observed one location where Sch. 40 ABS (black) plastic piping was installed.

Sink With ABS (black) Plastic Waste Piping

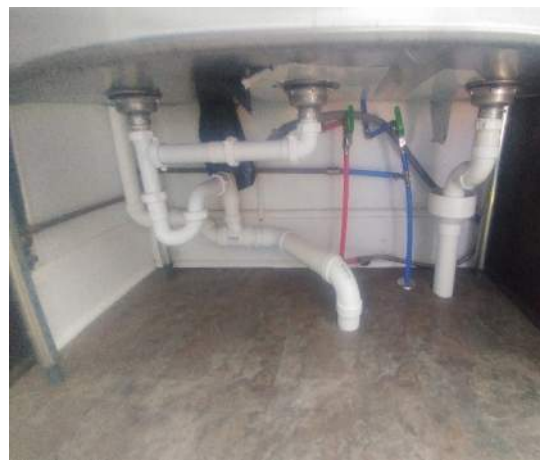
Sanitary Waste and Vent Piping - Kitchen

- Replace plumbing piping as necessary in areas of holistic renovation projects.

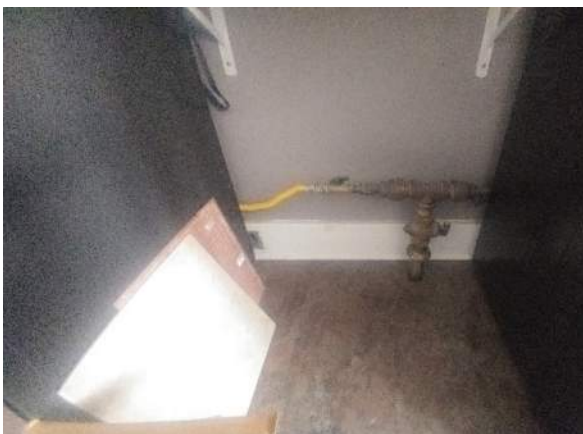
- Sch. 40 threaded black steel piping connects to underground piping in the crawlspace and extends up to the kitchen area.

Natural Gas Piping Between Two Ranges in Kitchen

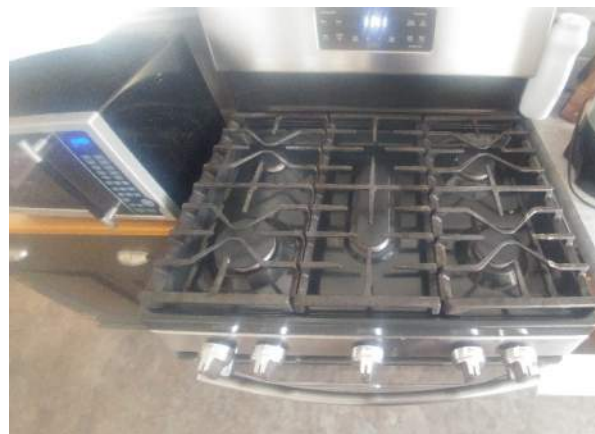
Natural Gas Range in Kitchen

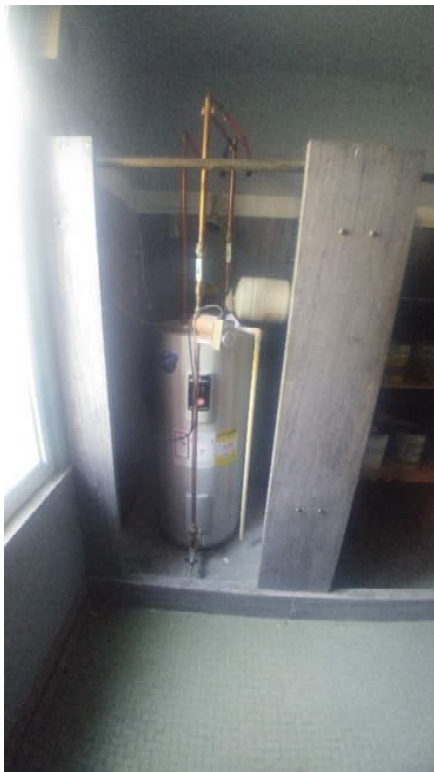
- Observed 40-gallon storage type electric water heating system with circulation pump and thermal expansion tank located in the first floor Girls Toilet Room abandoned shower stall. Appears to be in good condition.
- Observed 40-gallon electric water heater in the kitchen area. Appears to be in good condition.

Electric Water Heating System – Girls Toilet Room

- Replace water heaters on an as-needed basis.
- Consider relocating water heater from Girls Toilet Room to safer location.
- Consider adding a thermal expansion tank for the kitchen water heater to extend life of equipment.

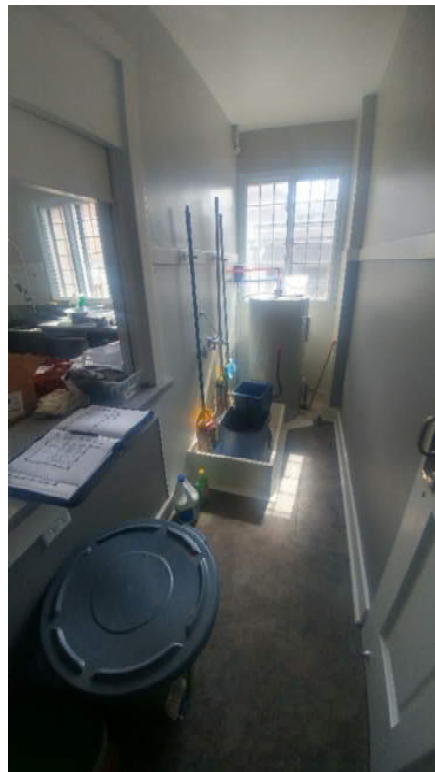
Electric Water Heater – Kitchen Area

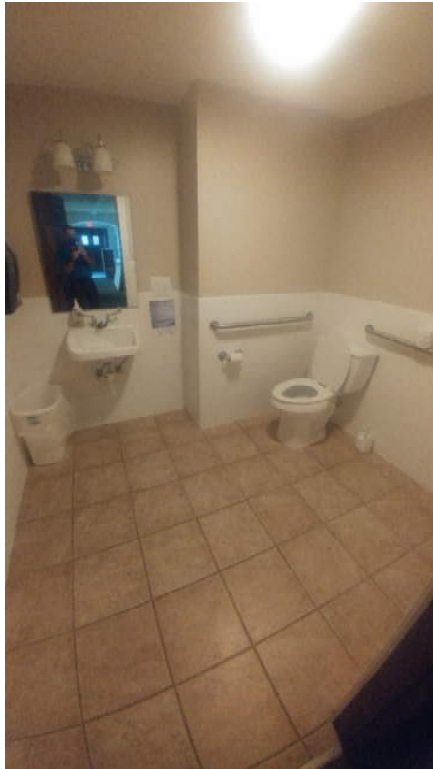
Observed toilet room fixtures to be in good condition – some have been updated during more recent renovation projects.

- Water Closets (Toilets) are floor mounted tank-type – all observed appear to be in good condition.
- Urinals are flush valve operated – all observed appeared to be abandoned. Replace urinals and piping as needed as part of long-term need.
- Lavatories – some are wall-mounted, some are countertop style.
- Sinks – Stainless steel counter-mounted.
- Showers – all seem to be abandoned. Replace showers and piping as needed as part of long-term need.
- Drinking Fountains – appear to have been removed – perhaps resulting from infection control measures.

First Floor Toilet Room

- Replace fixtures and/or trim on an as-needed basis.
- Consider installing bottle filling stations in lieu of drinking fountains.

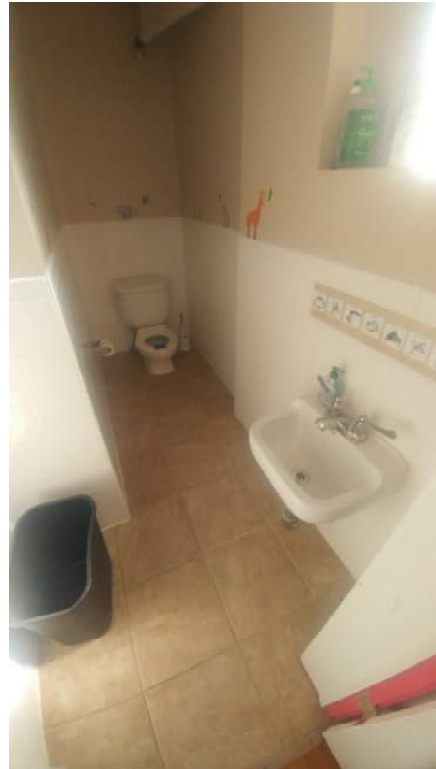
First Floor Classroom Toilet Room

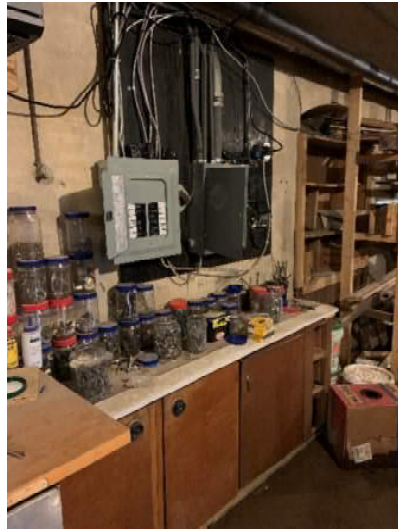
3.5.2.1.2 Two Panels in the basement area are mounted above a worktable/cabinet, not complying with code. In addition, one of these panels provides a 50A/2P sub feed to the other. It appears to be an unprotected multi conductor cable. Refer to Appendix B for code references.

Figure 2 - Basement Panels

- Move the worktable/cabinet.
- Protect the multi conductor cable between panels with a steel sleeve or plate not less than 1/16" thick.

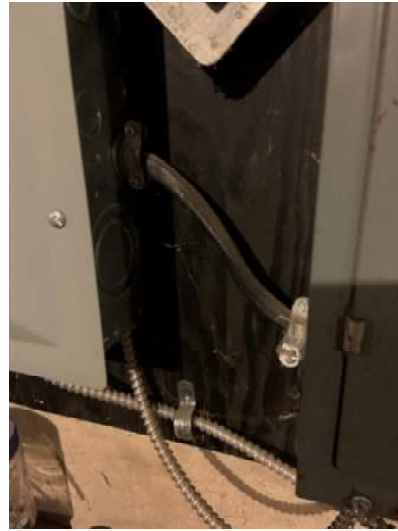
Figure3 - Cable at Basement Panels

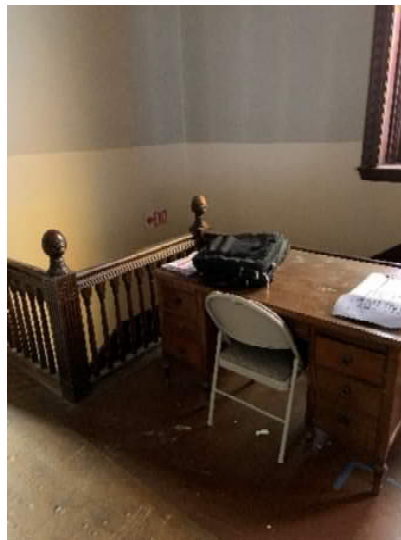
- 3.5.2.2.1 Existing Interior lighting appears to be a mix of compact fluorescent (CFL), and fluorescent type. Lighting is generally in good working order.
- As screw-in compact fluorescent lamps fail, replace them with LED screw-in type lamps.
- 3.5.2.2.2 Controls generally do not comply with code regarding automatic off features and light reduction requirements. Refer to Appendix b for code references.
- Add occupancy sensors and dimming or other light reduction switching to meet code.
- 3.5.2.2.3 Emergency lighting does not offer sufficient coverage required by code. Areas that require emergency lighting include the basement, stairs at the choir loft, rehearsal room, and stairs outside the rehearsal room. Refer to Appendix B for code references.

Figure 6 - Stairs Outside Rehearsal

- Add additional emergency lights in interior exit access pathways. on each floor and in areas indicated above.
- 3.5.2.2.4 Exit signage. Additional exit signs are required in locations where the way to reach an exit is not readily apparent per code. Additional emergency lighting is required to illuminate unlighted exit signs in some areas. An example of an area needing signage is the basement. Some examples of signs needing illumination are the signs in the basement, stair from second floor/choir, and signs at west end of sanctuary. Refer to Appendix B for code references.
- Provide exit signs and emergency illumination for signs to meet code requirements.

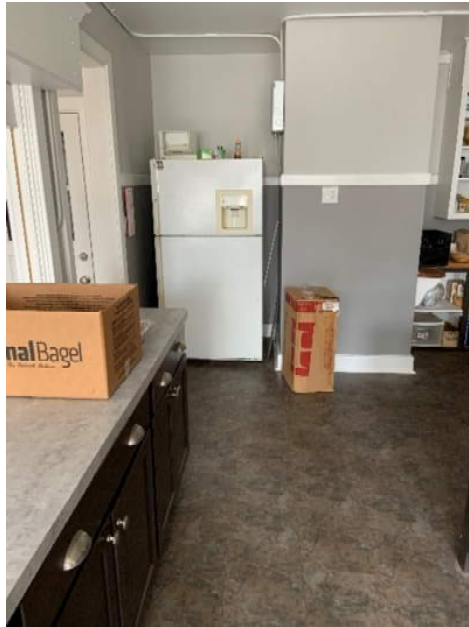
3.5.3.1.1 Power Distribution: Kitchen panelboard. The panelboard near the refrigerator does not meet code for required clearances. Refer to Appendix B for code references.

Figure 7 - Kitchen Panel Wide View

- Relocate this panel (location and height) to meet code.

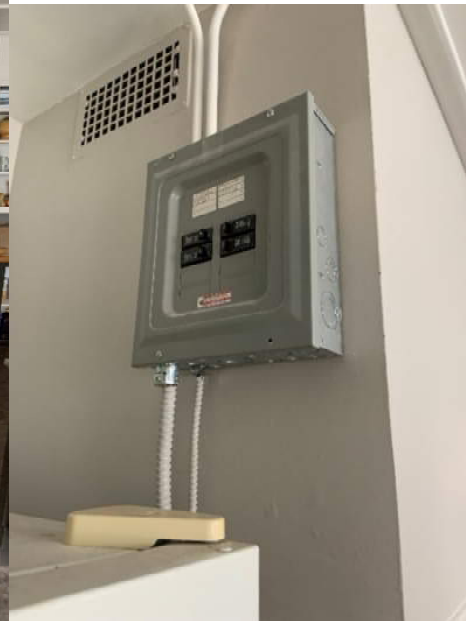
Figure 8 - Kitchen Panel

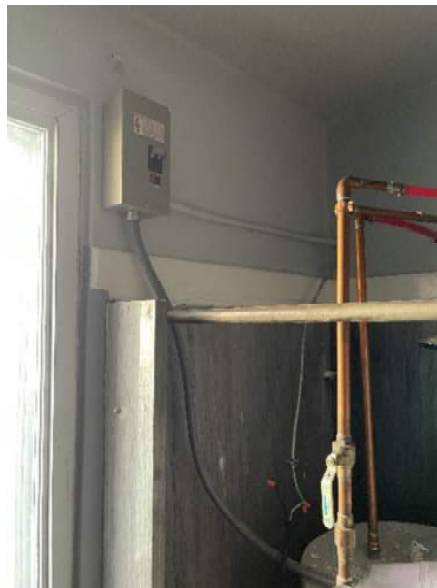
3.5.3.1.6 Hot water heater in former toilet room. The disconnect switch is not accessible at almost 7' AFF. Wiring to the recirculation pump is partially exposed

Figure 10 - HW Heater Electric

- Relocate the disconnect switch such that it is accessible.
- Rewire recirc pump to include a disconnect and eliminate the exposed splice, using junction box(es) per code where required. Refer to Appendix B for code references.

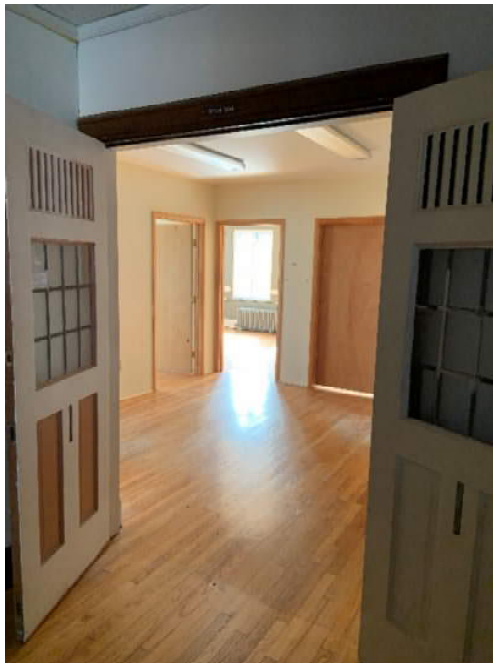
Figure 11 - 3rd Floor East Corner

- 3.5.3.2.5 Exit signage. Additional exit signs are required in locations where the way to reach an exit is not readily apparent per code. Additional emergency lighting is required to illuminate unlighted exit signs in some areas. An example of an area needing signage is the third-floor east corner where added rooms created an open area before the exit pathway. Some examples of signs needing illumination are the signs in the first-floor school corridor, as well as second and third floor hall. Refer to Appendix B for code references.
- Provide exit signs and emergency illumination for signs to meet code requirements.
